Restoration of historic John Biggers mural underway

Art restorer Scott Haskins works on the mural titled "The Contribution of the Negro Woman in American Life and Education," Monday, Jan. 14, 2019, in Houston. The mural was created by Dr. John Biggers in 1953 and is located at the Blue Triangle Community Center. The mural was severely damaged by Hurricane Harvey.

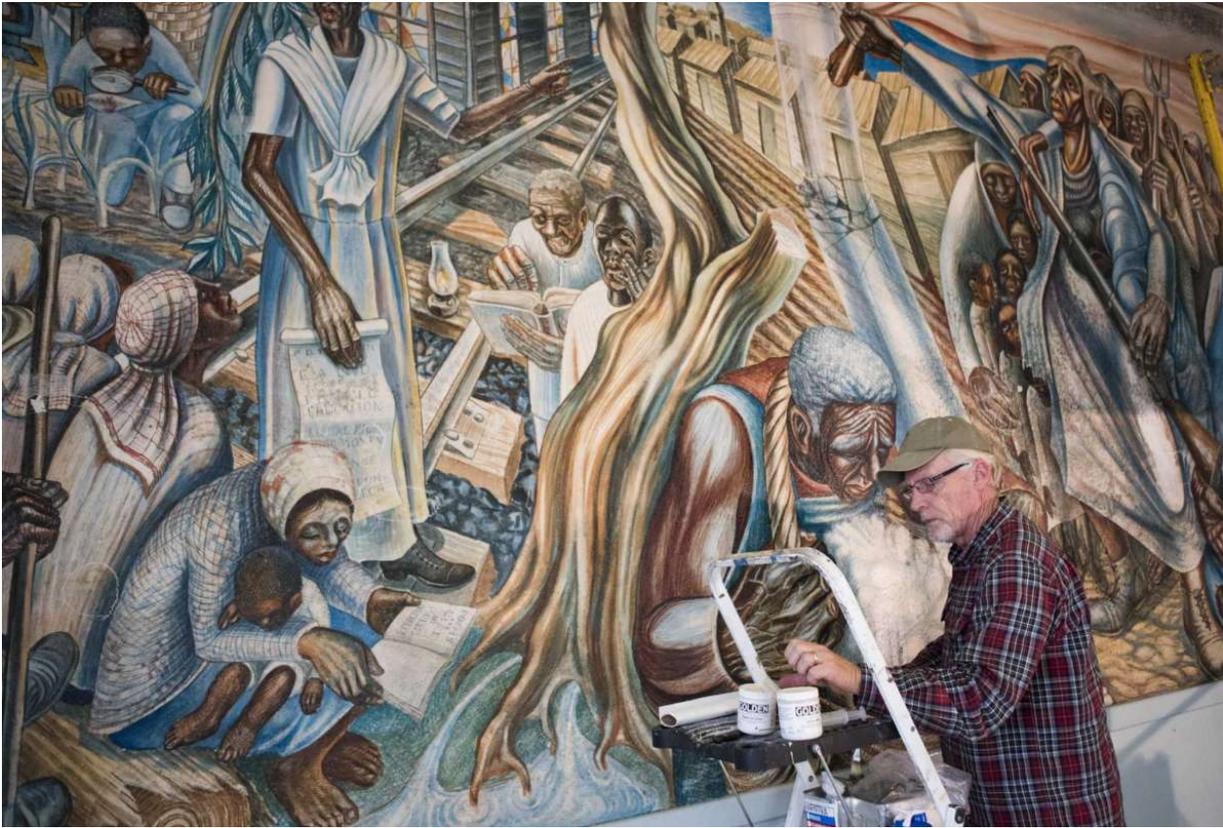
The 1953 masterpiece, "Contribution of Negro Women to American Life and Education," suffered damage during Hurricane Harvey. Flood waters that seeped into the wall the mural is painted on caused the structure to swell and black mold grew into the paint.

When Haskins saw images of the initial damage the Third Ward mural sustained, he said he grew concerned about the painting's stability. The mold looked like it was "growling at you," he said, and the wall on which the mural was directly painted on had a spongy quality to it.

After Harvey, staff from the Houston Museum of Fine Arts treated the painting, adding dehumidifiers to the room, partially covering the damaged roof overhead, filling in paint gaps with Japanese tissue paper. That temporary work succeeded in stabilizing the mural and the wall.

Since the mural is composed of several layers of paint, Haskins is going through each layer, removing mold where he can and dotting in color-matched paint in areas where paint chips have popped off. The work requires a steady hand as some portions of the mural have colors so sensitive, they can disappear with human saliva, he said.

Once all gaps are filled and the mold is fully removed, Haskins plans to apply a protective varnish.
